### **Experimental evaluation of in-plane shear behaviour of masonry walls retrofitted using conventional and innovative methods**

# Experimental Evaluation of In-plane Shear Behaviour of Masonry Walls Retrofitted Using Conventional and Innovative Methods

M. CORRADI<sup>1</sup>, A. BORRI\* and A. VIGNOLI\*\*

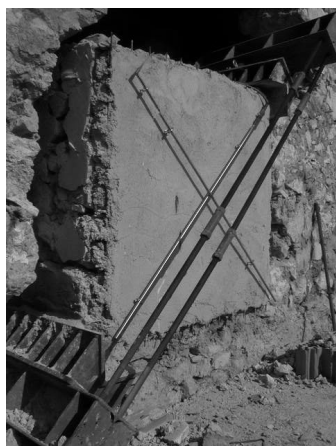
**Figure 1** Concrete jacketing applied to a masonry panel

Strengthening by jacketing of rubble or cut, dimensioned stone masonry walls is an effective way to increase walls' shear resistance and lateral stiffness. Four masonry panels were reinforced with this method in order to compare the results with the other retrofitting methods applied to the same building and masonry wall. The concrete was applied by shotcreting and a total thickness of coating of 40-50mm was used (Figure 1). The coating was applied in two layers. After completing the first layer of shotcrete the steel (FeB 44K type) mesh (100 x 100mm, rebar diameter 6mm) was installed and then the second layer was applied. The steps for ferrocement reinforcement, applied to rubble or cut-stone masonry walls, were:

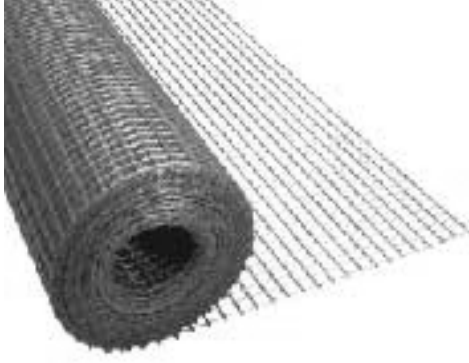
Figure 5 GFRP mesh (IG type)

The GFRP mesh (IG type) has a thickness of 0.67mm and has an opening of 10mm in longitudinal direction and 9mm in transversal direction (Figure 5). The main mechanical characteristics, declared by the manufacturer, are shown in Table 4. A coating made of hydraulic based mortar was used. The average compressive strength of the mortar was  $3.3\text{N/mm}^2$ . After the application was finished, each grid

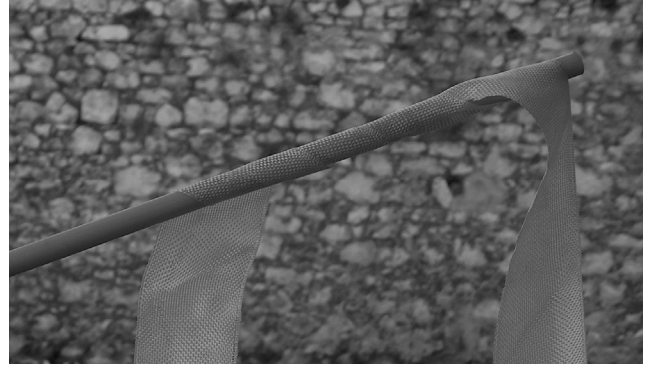
Figure 6 Connection between GFRP bar and sheet

For both uni-directional glass fibre and GFRP mesh reinforcement, through holes were drilled for  $\phi 12\text{mm}$  GFRP rebars anchors at  $5/\text{m}^2$ . Rebars were wrapped with GFRP sheets connected to the external reinforcement (Figure 6).

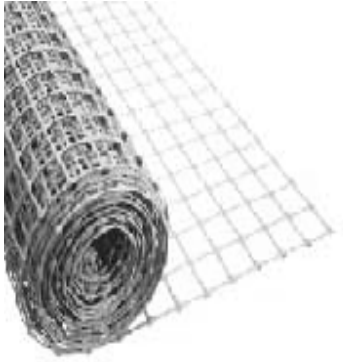
Figure 7 Polypropylene mesh

While extensive research was conducted for retrofitting of masonry structures using FRP, much less was reported for retrofitting of unreinforced masonry structures with polypropylene nets (Figure 7).

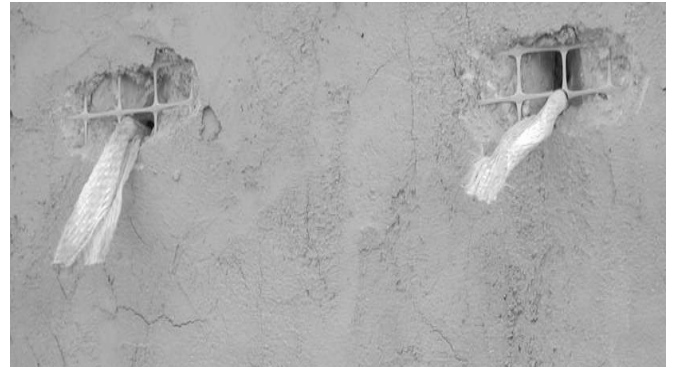
Figure 8 Connection between through anchors and polypropylene reinforcement: bars are wrapped with GFRP sheets and fixed to the polypropylene mesh using epoxy-resins

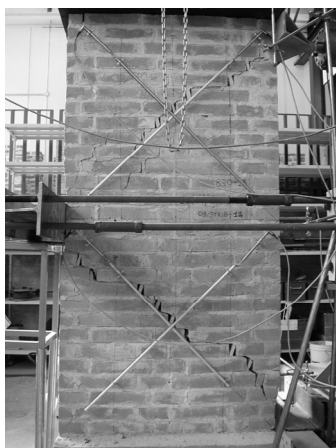
Figure 15 Unstrengthened brick panel: failure mechanism

Solid brick panels, although stepped shear friction cracks were observed, failed due to shear slide at the bed joints (Figure 15), with a characteristic shear strength  $\tau_k$  of  $0.188\text{N/mm}^2$  and a shear modulus  $G$  of  $207\text{N/mm}^2$ . The test results are compared in Table 7.

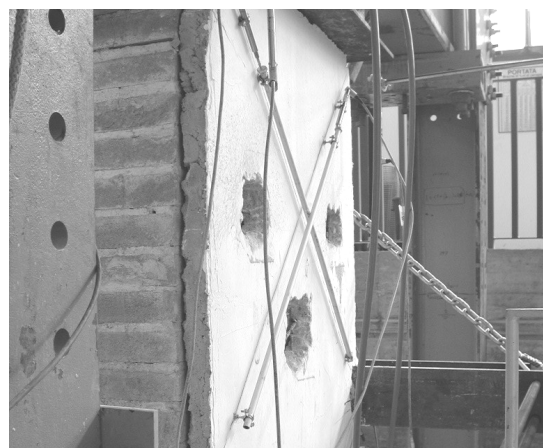
Figure 16 Ferro-cement: failure mechanism

and for repair, but it causes very high increases of shear stiffness ( $\tau_k = 0.205\text{N/mm}^2$ , +127%;  $G = 630\text{N/mm}^2$ , +472%). For tests TC-31-L-IT-P, TC-37-L-IT-R and TC-44-L-IT-R, no clear cracks were observed and the failure was caused by a debonding of concrete jacketing from masonry surface (Figure 16).

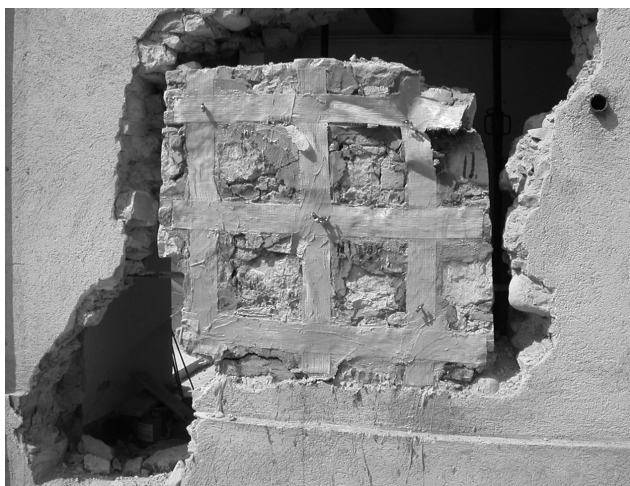
**Figure 19 A panel retrofitted with GFRP sheets**
